**BARRINGTON TOWN OFFICES
STUDY FOR REMEDIATION, RENOVATION OR RELOCATION**

EXISTING BUILDING EVALUATION

Field Observation Report

Civil/Site Photos

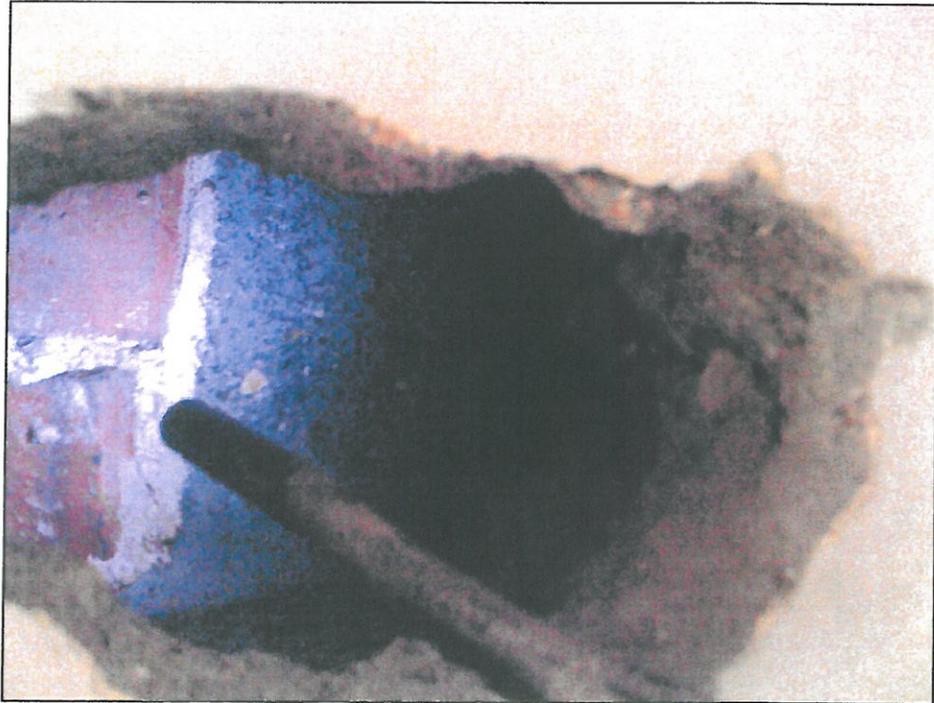
Hole 1 – 1950's Wing (old nurses office / under the back stairs). The wall thickness was 12-3/8 inches thick (with a true 8-inch Concrete Masonry Unit (CMU) block). We found no air space between the brick and the block. Every 6th course was a Flemish bond or a tie course that connected into the block. The block was cut to accept the brick. There were no brick ties. In addition, the cavity was very dry (as expected this time of year). We looked up and down the wall cavity with the scope camera and there was no visible mold in this area. We took two samples of the block at this location.

Core of CMU block; visible brick is tie to brick veneer.

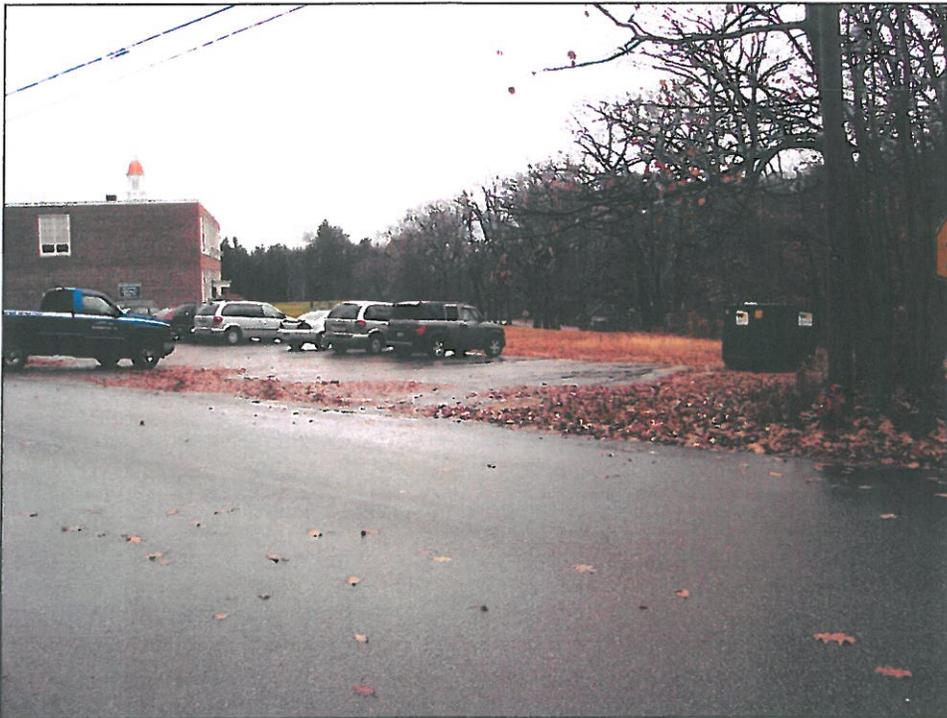
Civil Photo 4: Dumpster location, looking southeast from Ramsdell Lane.

- Construct a concrete dumpster pad to provide a more firm, impervious surface beneath the container. Provide a fence around the perimeter to establish visual screening (see Civil Photo 4).
- Install curbs around landscaped islands at upper parking lot to prevent damage to vegetation and to prevent soil from being flushed onto pavement (see Civil Photo 9).
- Pave gravel access drive on east side of structure, linking upper lot to paved driveway intersecting with Route 9. If the door on the east end of Town Hall is to be used as a means of accessible access, provide an ADA compliant pedestrian route from the parking spaces to the entrance (see Civil Photo 10).
- Pave the gravel parking area and stripe parking spaces. Additional accessible spaces may be required with an addition of delineated spaces (see Civil Photo 11).

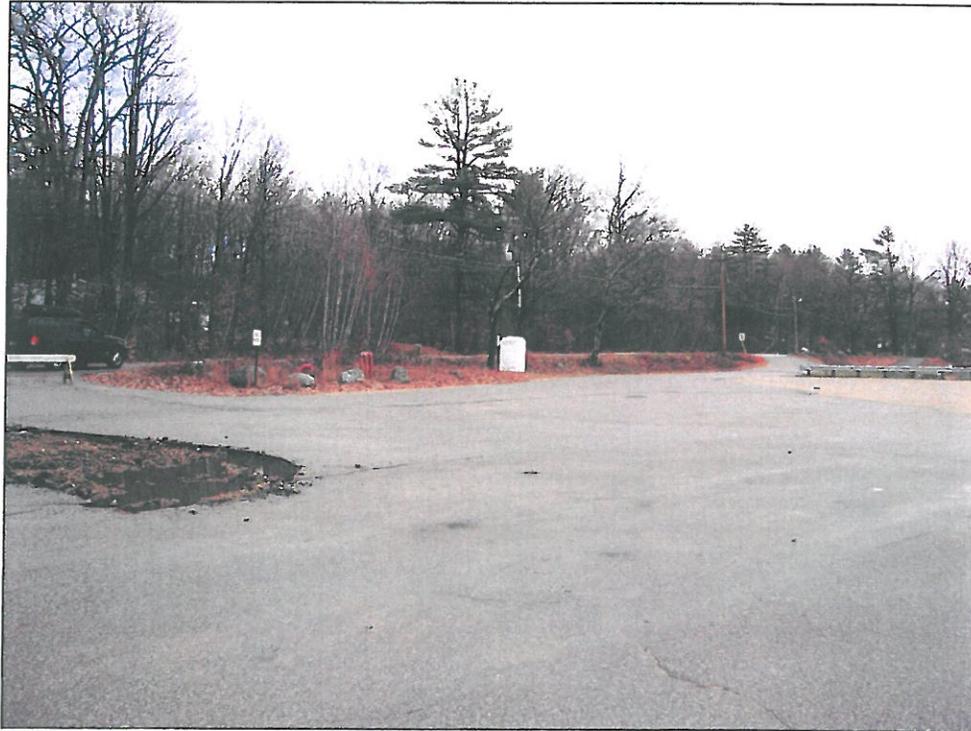
Civil Photo 9: Upper lot, uncurbed landscaped island at left side, looking northeast.

COMPONENT	OBSERVATION	RECOMMENDATION	Remaining Useful Life	Replacement/Upgrade Cost
Upper parking lot (north side of building).	Landscaped islands flush with pavement.	Install curbing to protect material planted in islands and to prevent soil/mulch from flushing onto parking area.		Granite: \$4,500.00 Bituminous: \$2,000.00
Gravel driveway on east side of building, connecting upper lot and driveway off of Route 9.	Gravel material washed off of slope onto paved driveway by runoff.	Pave gravel driveway. Pave and stripe the gravel parking area, if the area is utilized as parking.		Driveway: \$8,000.00 (Gravel Parking: \$20,000.00)
Dumpster	Well-situated for ease of access by garbage truck, but it is unscreened and sits on bare ground.	Place concrete pad for dumpster to sit upon. Install fence around dumpster to provide visual screening.		\$2,500.00
Site Lighting	Extremely minimal.	Develop site lighting plan to provide greater visibility, security, and aesthetic appeal, while preventing off-site light spillage.		Included in Electrical Costs

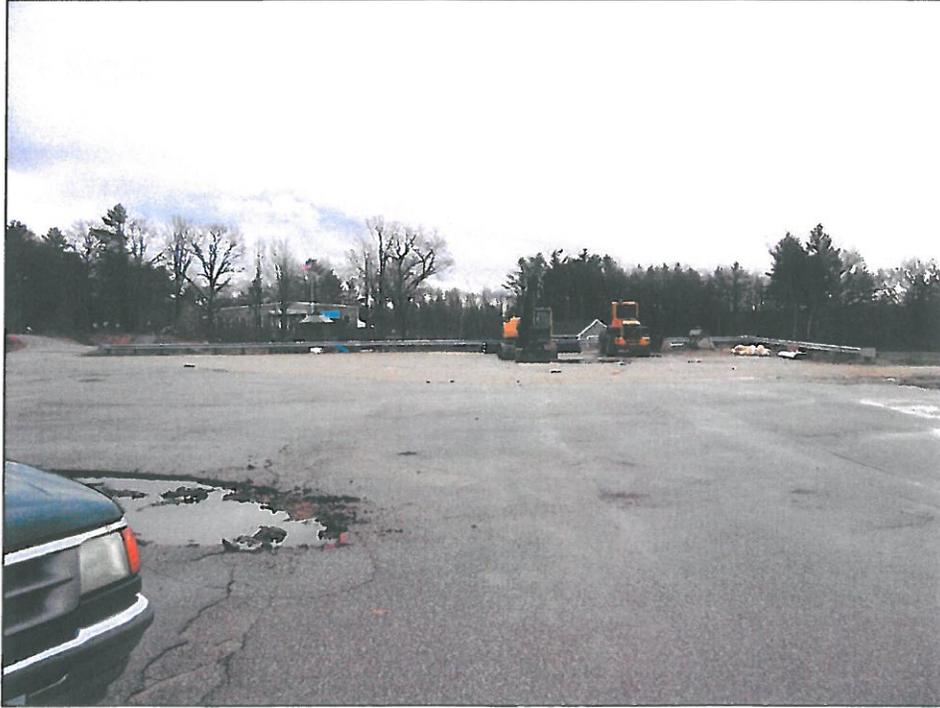
Civil Photo 11: Upper lot looking east toward gravel parking area.

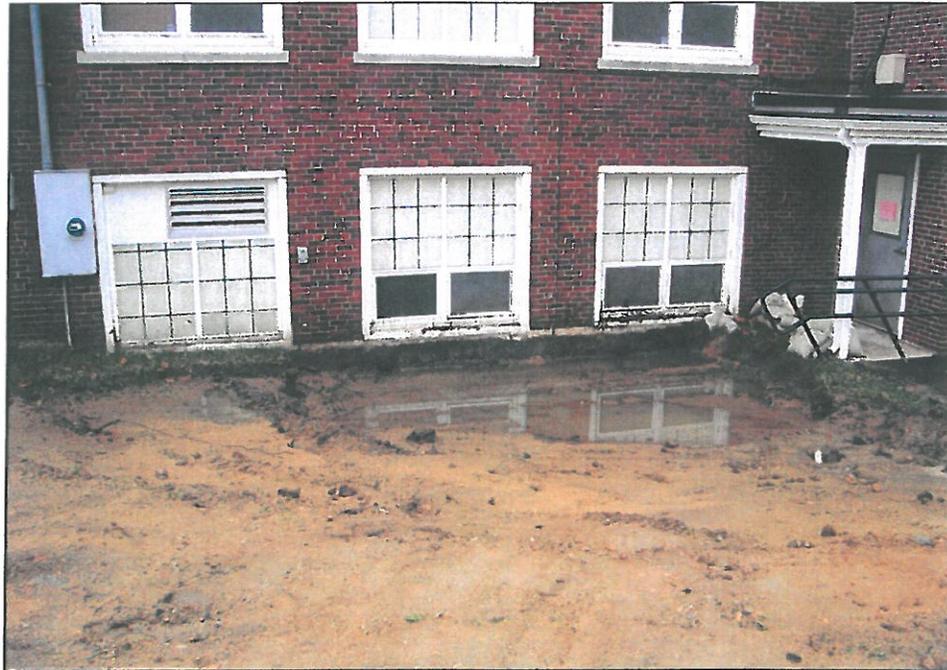
COMPONENT	OBSERVATION	RECOMMENDATION	Remaining Useful Life	Replacement/Upgrade Cost
Grade along north side of building.	Little separation between windowsills and finish grade. Finish grade flush with concrete door pad and asphalt walk on north side of building.	Provide minimum 4" vertical separation between finish grade and windowsills. Slope grade away from sidewalk and door pad.		\$2,000.00
Accessible ramp from upper parking lot to entrance.	Ramp is not compliant with ADA regulations (too steep). Handrail is not compliant with ADA.	Reconstruct ramp and replace handrail in accordance w/ ADA specifications. Alternatively, relocate accessible parking spaces (see below).		\$10,000.00
Accessible parking spaces.	One located at lower lot, two located at upper lot.	Restripe lower parking lot (west side of facility) so all accessible spaces are located adjacent to accessible entrance. Ensure new spaces meet all ADA regulations.		\$1,000.00

Civil Photo 12: Finished grade at windows and door pad.

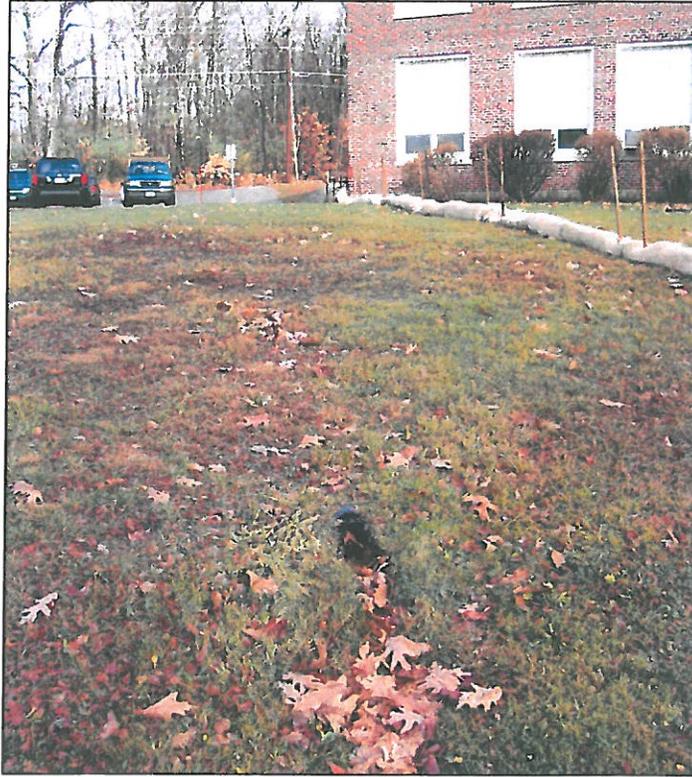
Culvert Outlet - Southwest Corner of Facility	Absence of outlet protection creating rill erosion on vegetated slope facing Route. 9	Install outlet protection (riprap or similar) at outlet to prevent erosion. Repair existing erosion and reseed.			\$500.00

Civil Photo 13: Existing outlet from drop inlet.

- Construct stabilized outlet at daylighted culvert off southwest corner of building (see Civil Photo 13). Repair and reseed rill erosion in grassed slope.

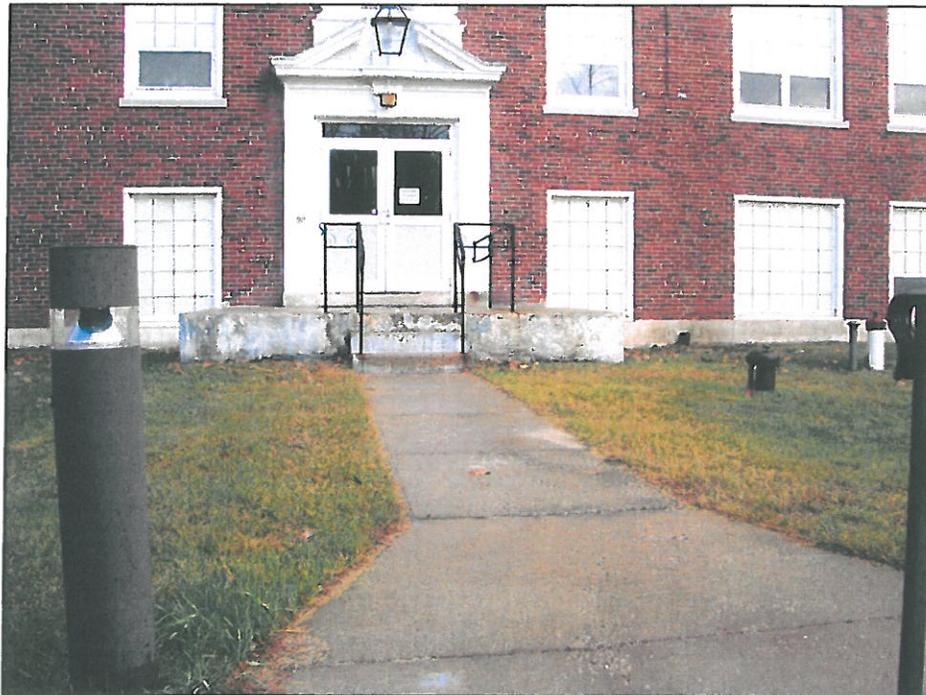
Civil Photo 14: Existing stairs at employee entrance.

- Exterior site lighting should be added to illuminate the parking lots and pathways.
- The front steps at the employee entrance should be reconstructed or repaired and the railings should be replaced to meet current regulations (see Civil Photo 14).
- Replace railings at accessible ramp and stairways to be ADA compliant.
- Spring 2011 - Inspect the seed that was planted in the fall of 2010 to assess germination. If necessary, reseed and restabilize. Review performance of yard drains and their effectiveness at removing standing surface water, particularly during spring thaw and spring rains (see Civil Photos 15 - 18).
- Review performance of yard drains, particularly during spring thaw and spring rains.

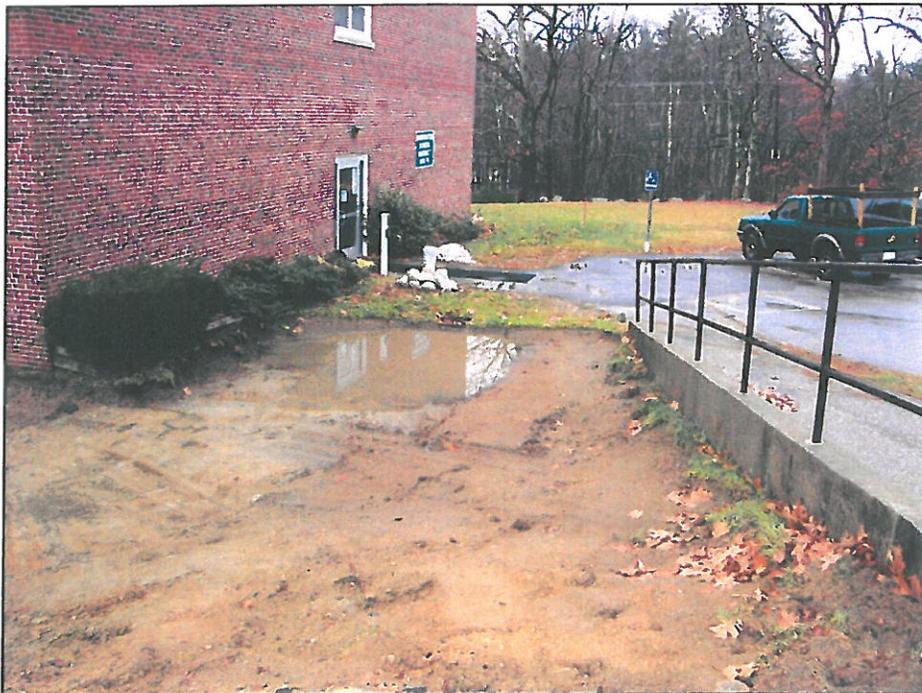
COMPONENT	OBSERVATION	RECOMMENDATION	Remaining Useful Life	Replacement/Upgrade Cost
Exterior railings at stairs and walkways.	In various states of adequacy and ADA compliance.	Replace railings for safety and consistent ADA compliance.		\$4,000.00
South side stairs (employee entrance).	Very weathered.	Repair or replace.		Included in Architectural Costs.
Fall 2010 seeding	Installed late in growing season.	Review status of germination in springtime. Reseed if unsuccessful.		--
Yard Drains	Installed during fall of 2010.	Review performance of drains during spring thaw and rainy season.		--
			SUBTOTAL	\$90,000.00 – \$112,500.00

Civil Photo 16: Existing drop inlet and non-ADA compliant handrail.

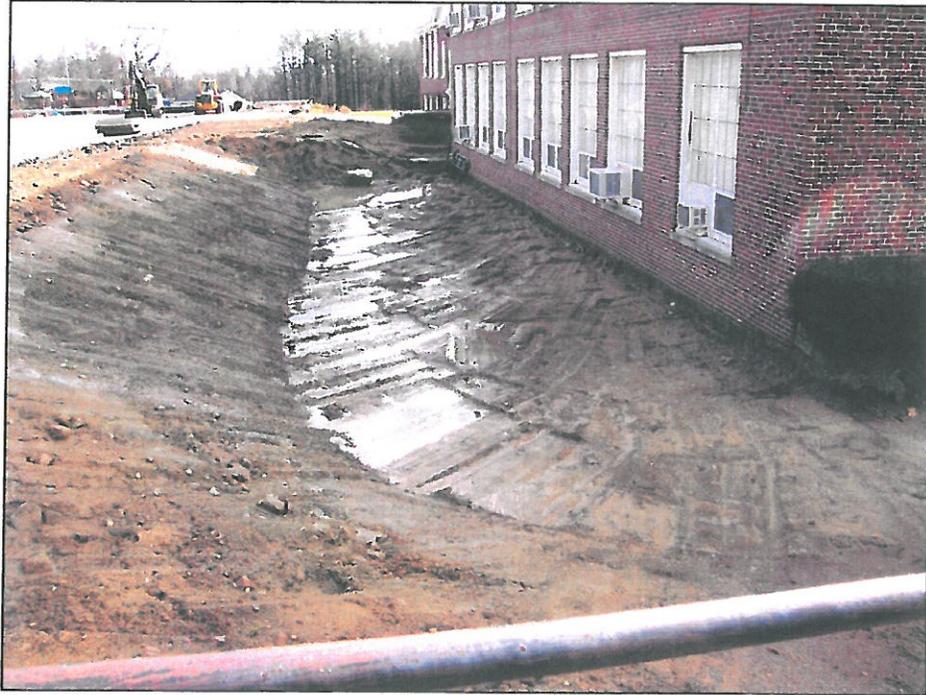
COMPONENT		OBSERVATION	RECOMMENDATION	Remaining Useful Life	Replacement/Upgrade Cost
Footing Drains	Installed in fall of 2010. Not installed around entire perimeter of below-grade spaces.	Install additional footing drains at perimeter of all below ground spaces. Pipe should be surrounded by stone-wrapped geotextile (installed foundation drain is so constructed). Approx. 120 lf required.			\$6,000.00
Foundation Walls	No waterproofing or insulation appears to have been installed against exterior face of foundation at below-grade spaces.	Apply waterproofing to exterior of foundation walls and install rigid insulation/drainage board. Backfill trench with free draining material. (340 lf +/-)			\$18,000.00
Drip Edge/Surface Drains	Absence of stone drip edge beneath portion of building with sloping roofs. New yard drains installed in fall 2010 to manage surface runoff on north side of building.	Install 6' - 8' wide, 12" deep stone drip edge with 2" - 3" stone beneath all sloping roofs. Place perforated drain pipe at bottom of stone and daylight to drain. (230 lf +/-)			\$12,000.00

Civil Photo 17: Drainage improvements in progress (fall 2010).
