Bridge Inspection Report**Barrington 109/162****Date of Inspection:** 09/15/2011**Date Report Sent:** 12/9/2011☒ **Picture taken during inspection****Owner:** Municipality**GREEN HILL ROAD****Over****ISINGLASS RIVER****Recommended Postings:****Weight:** C2☒ **Weight Sign OK****Width:** Not Required☒ **Width Sign OK****NARROW BRIDGE SIGNS****Primary Height Sign Recommendation:** None**Optional Centerline Height Sign Rec:** None**Clearances:** Over:
(Feet) Under: 0.00
Route:☒ **Height Signs OK****Condition:** Not on the Redlist**Deck:** 6 Satisfactory**Superstructure:** 7 Good**Substructure:** 6 Satisfactory**Culvert:** N N/A (NBI)**Structure Type and Materials:****Number of Spans Main Unit:** 1**Number of Approach Spans:** 0**Main Span Material and Design Type****Steel Multiple Beam****Sufficiency Rating:** 69.1%**NBI Status:** Functionally Obsolete**Bridge Rail:** Substandard**Rail Transition:** Substandard**Bridge Approach Rail:** Substandard**Approach Rail Ends:** Substandard**NH Bridge Type:** I Beams w/ Concrete Deck**Deck Type:** Concrete, Cast in Place**Wearing Surface:** Bituminous**Membrane:** None**Deck Protection:** None**Pavement thickness:** 3.0 in**Curb Reveal:** 6.0 i

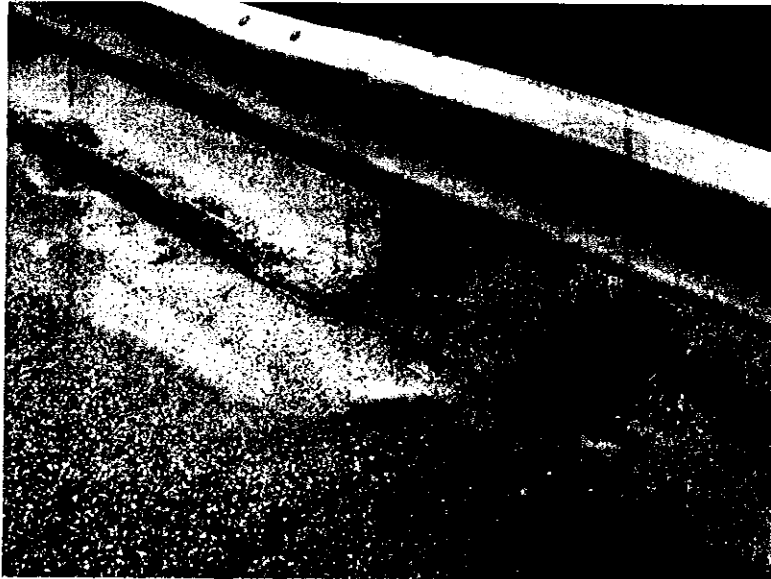
C437 31

DECK: DECK UNDERSIDE HAS FINE CRACKS, MODERATE LEAKING. CONCRETE CURBS HAVE FINE CRACKS AND SPALLS WITH REBAR EXPOSED AT NORTHEAST. MINOR SPALLS AT POSTS. W-BEAM RAIL WITH PAINTED STEEL POSTS; POSTS RUSTED. SUPERSTRUCTURE: STRINGERS HAVE LIGHT RUST AREAS. PAINT IS FLAKING. BEARINGS ARE RUSTED.

31. CURB SPALLED WITH REBAR EXPOSED AT NORTHEAST.

CURB SPALLED WITH
REBAR EXPOSED AT
NORTHEAST
