PHASE II - FINAL REPORT
BARRINGTON TOWN OFFICES
STUDY FOR REMEDIATION,
RENOVATION OR RELOCATION

FOR
THE TOWN OF BARRINGTON, NEW HAMPSHIRE

FALL 2012

THE H. L. TURNER GROUP Inc.

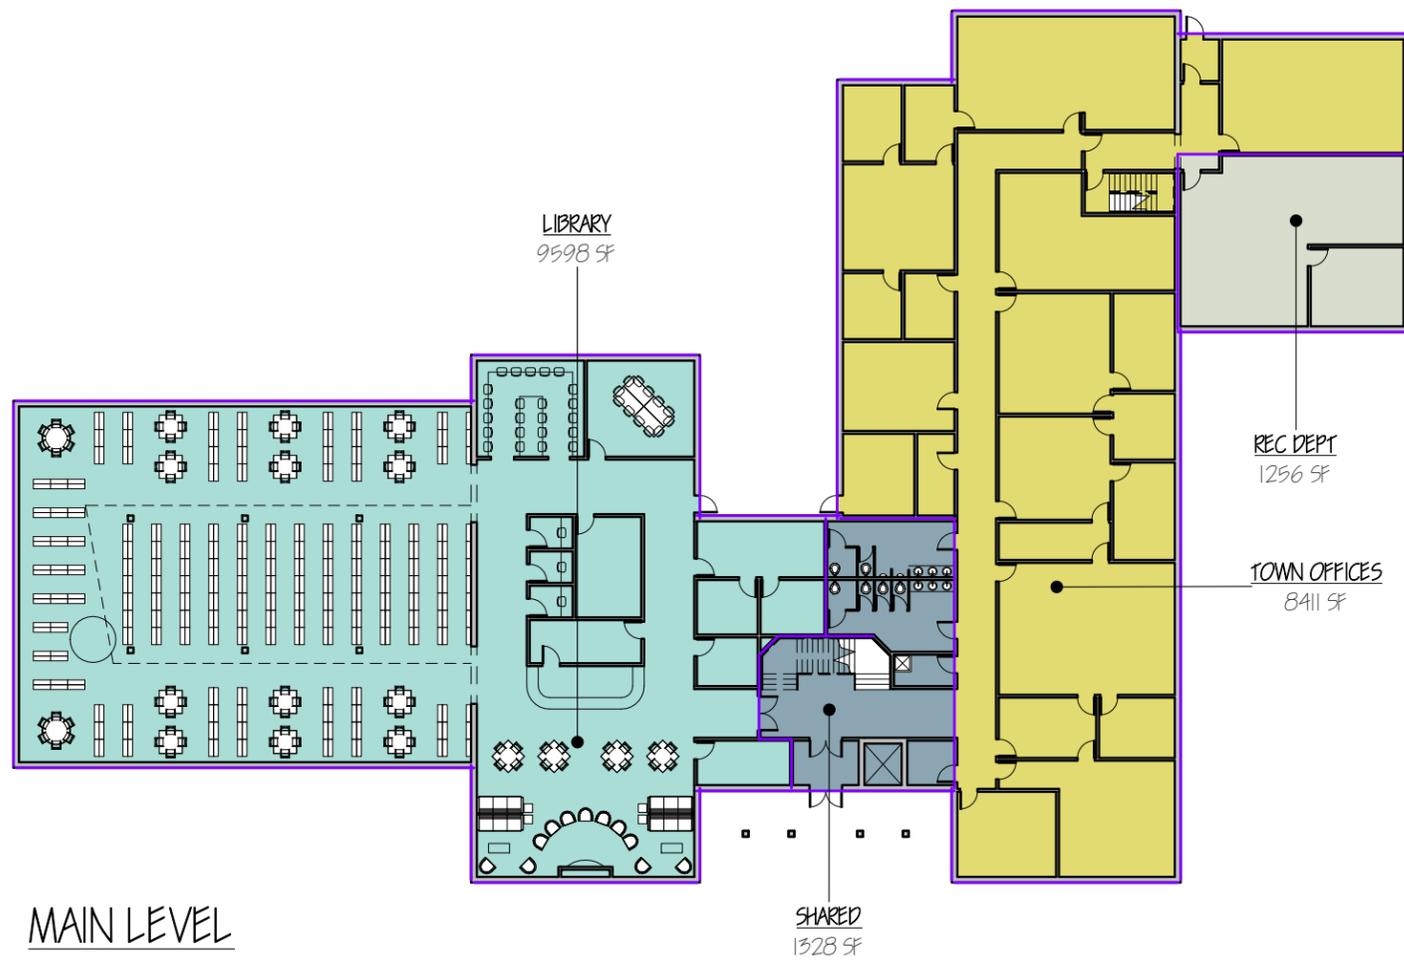
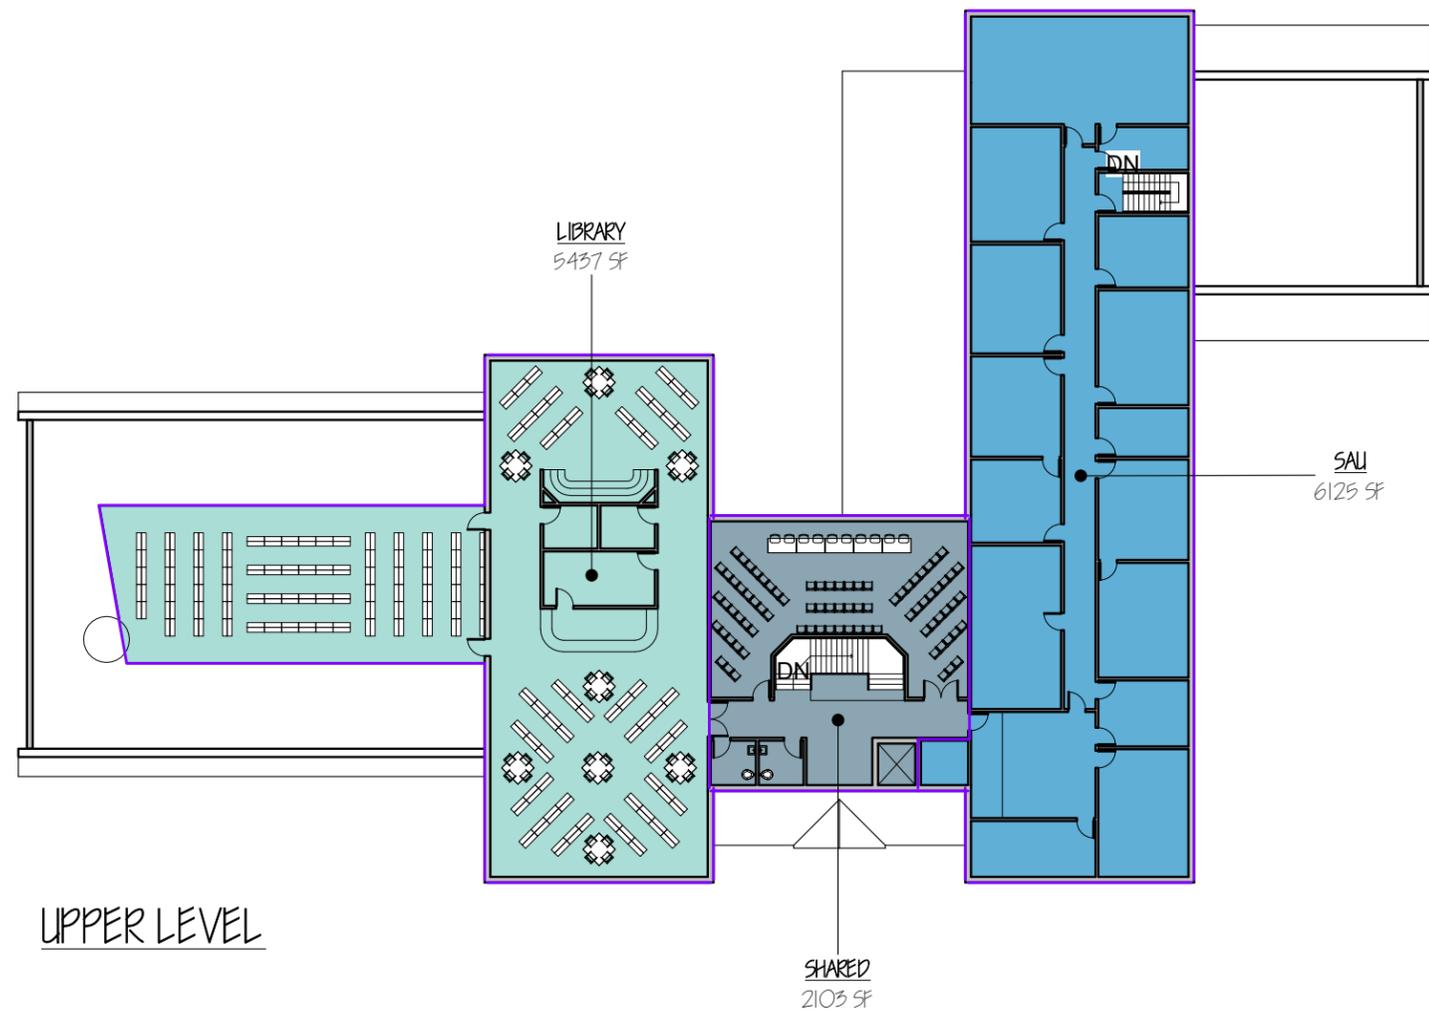
AREA PLANS

BUILDING AREA SCHEDULE

LIBRARY	15035 SF
REC DEPT	1256 SF
SAU	6125 SF
SHARED	3431 SF
TOWN OFFICES	8411 SF
TOTAL	34258 SF

The new Town Complex is envisioned to include a Town Office Center, SAU Office Center, and a Town Library. Using the space programming information provided by the Committee, TTG generated a basic conceptual site plan layout of the building complex for the Town-owned Clark Goodwill site and for the Calef Site. Reference the drawings in Appendix B. The complex is configured with common areas to be shared between the Library, the SAU, and the Town Offices. The square footage breakdown is as follows:

- Library – Requested: 15,000 to 17,000 square feet
Proposed design: 15,060 square feet
- Recreation Department – Requested: 1,300 square feet
Proposed: 1,250 square feet
- School Administrative Unit – Requested: 6,350 square feet
Proposed: 6,125 square feet
- Town Offices – Requested: 10,800 square feet
Proposed: 8,410 square feet (but the large meeting room is part of the shared space)

The total requested square footage for the Library, Recreation Department, SAU and Town Offices is 33,000 square feet, and the proposed design provides for a total of 34,275 square feet on two levels.
