## **Barrington Community Center**

### Level II Energy Audit

**ADDENDUM ADDED September 26, 2023**

Prepared by: *Resilient Buildings Group, Inc.*

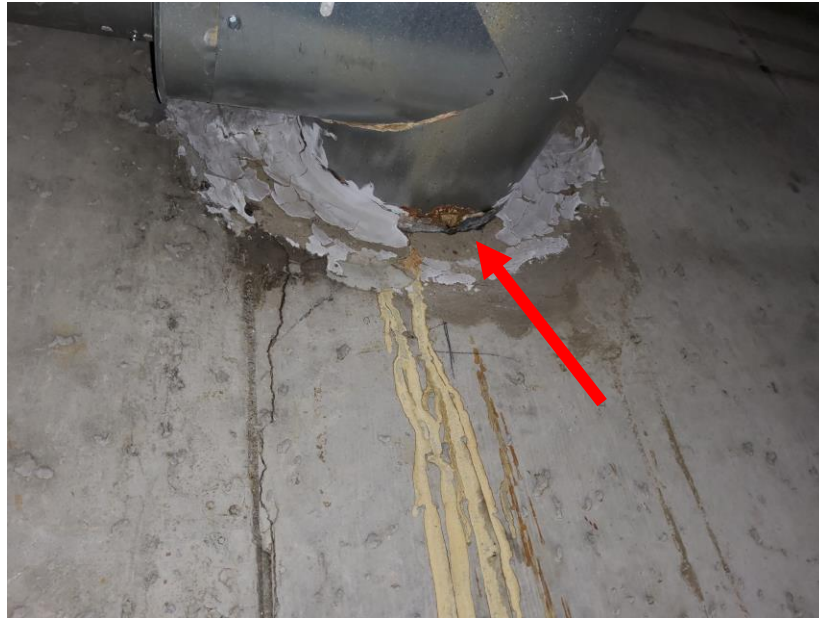
**Missing sealant around boiler exhaust**

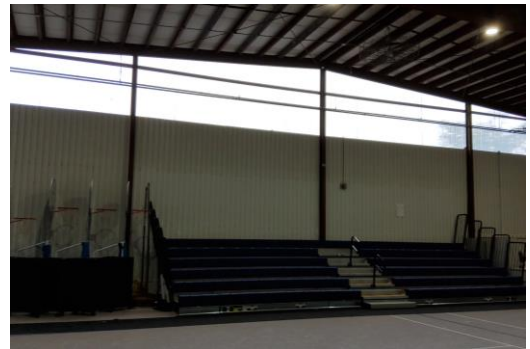
- **B1. EEM: Gym, Replace South East Wall and Windows.** The metal wall and plastic window currently in place do not adequately prevent heat transfer and therefore drastically compromise the building's energy efficiency. During the interview with the owner, we learned that this whole wall would be replaced. When replacing the metal wall, we recommend installing one with R-35 polyisocyanurate insulation. We also recommend replacing the plastic window with a fixed translucent daylight panel that has a minimum R-value of R-5 (U-value maximum of 0.2) (e.g. a Kalwall product).

Southeast Wall of Gym

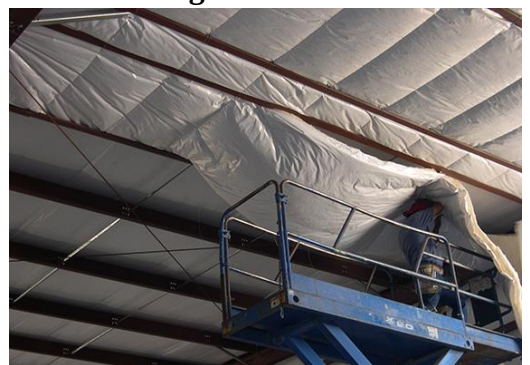
Gym Retrofit Insulation System

- **B2. EEM: Gym, Install Retrofit Insulation System and in Ceiling.** We recommend installing a retrofit insulation system between the metal purlins. With this system, a contractor will lay in suspended sealed layers of fiberglass insulation. This approach is quite a popular, cost-effective way to insulate gym roofs. There are contractors in New Hampshire that install these systems (e.g. TruTeam). The metal purlins in the gym seem to be about 10" in height, allowing for a 9" retrofit system. This would equate to about R-30.

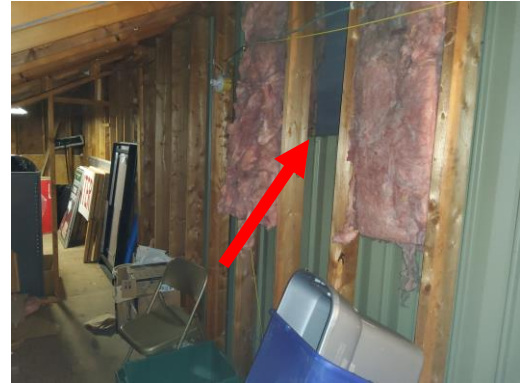
The surrounding walls and attic/roof of the gym and food pantry should be well-insulated and air-sealed to ensure an efficient building envelope. The space above the food pantry is currently being used for miscellaneous storage and does not seem to be included in the food pantry's conditioned space (space that is intended to be warm in the winter and cold in the summer).

Therefore, the attic floor above the food pantry space and the exposed section of the gym wall should be continuously air-sealed and insulated. At present, there is a large gap in the metal wall for the gym and the wall is not adequately insulated (discontinuous layer of 6" fiberglass batts). The attic floor has several un-sealed openings and is insulated with a discontinuous layer of 12" fiberglass batts, which equates to an R-value of only about R-30. We typically recommend establishing a continuous air-barrier and thermal barrier with an R-value of R-60. To approach this target in the food pantry, a weatherization contractor should use air-sealing measures and insulating measures to address the issues noted. A series of measures we recommend are: apply 6" of closed cell spray foam to the hole in the metal wall, air-seal the attic floor with one-part spray foam or caulking, insulate that attic floor with 10" loose-blown cellulose, and reinstall plywood boards if the space will continue to serve as storage space.

Uninsulated wall dividing gym and attic space

- **B3. EEM: Food Pantry, Air Seal and Reinsulate Attic Floor and Fill Hole in Metal Wall with Spray Foam.**
