The impact one man can have on the land.....

The next seven slides are aerial photographs (taken by the USDA) of the land on either side of Two Mile Road between Stepping Stones Road and US Route 4 in Barrington, NH.

The orientation of the slides changes, so I have labeled the landmarks to make it easier to follow the history of the land from 1953 until 2009.

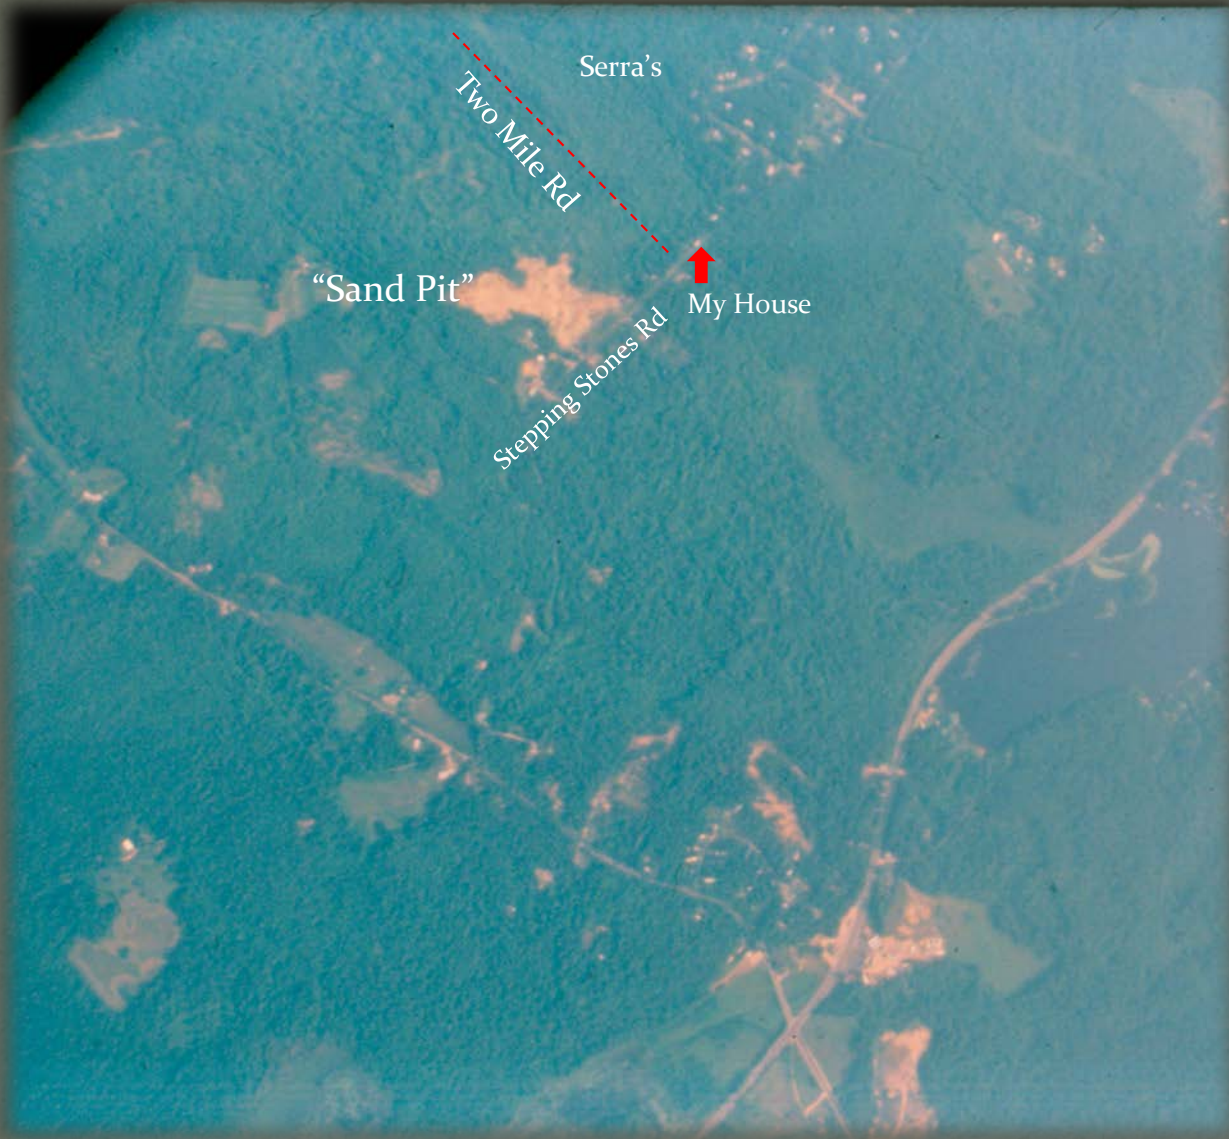
August
1984

Sand pit in
upper
center of
slide.

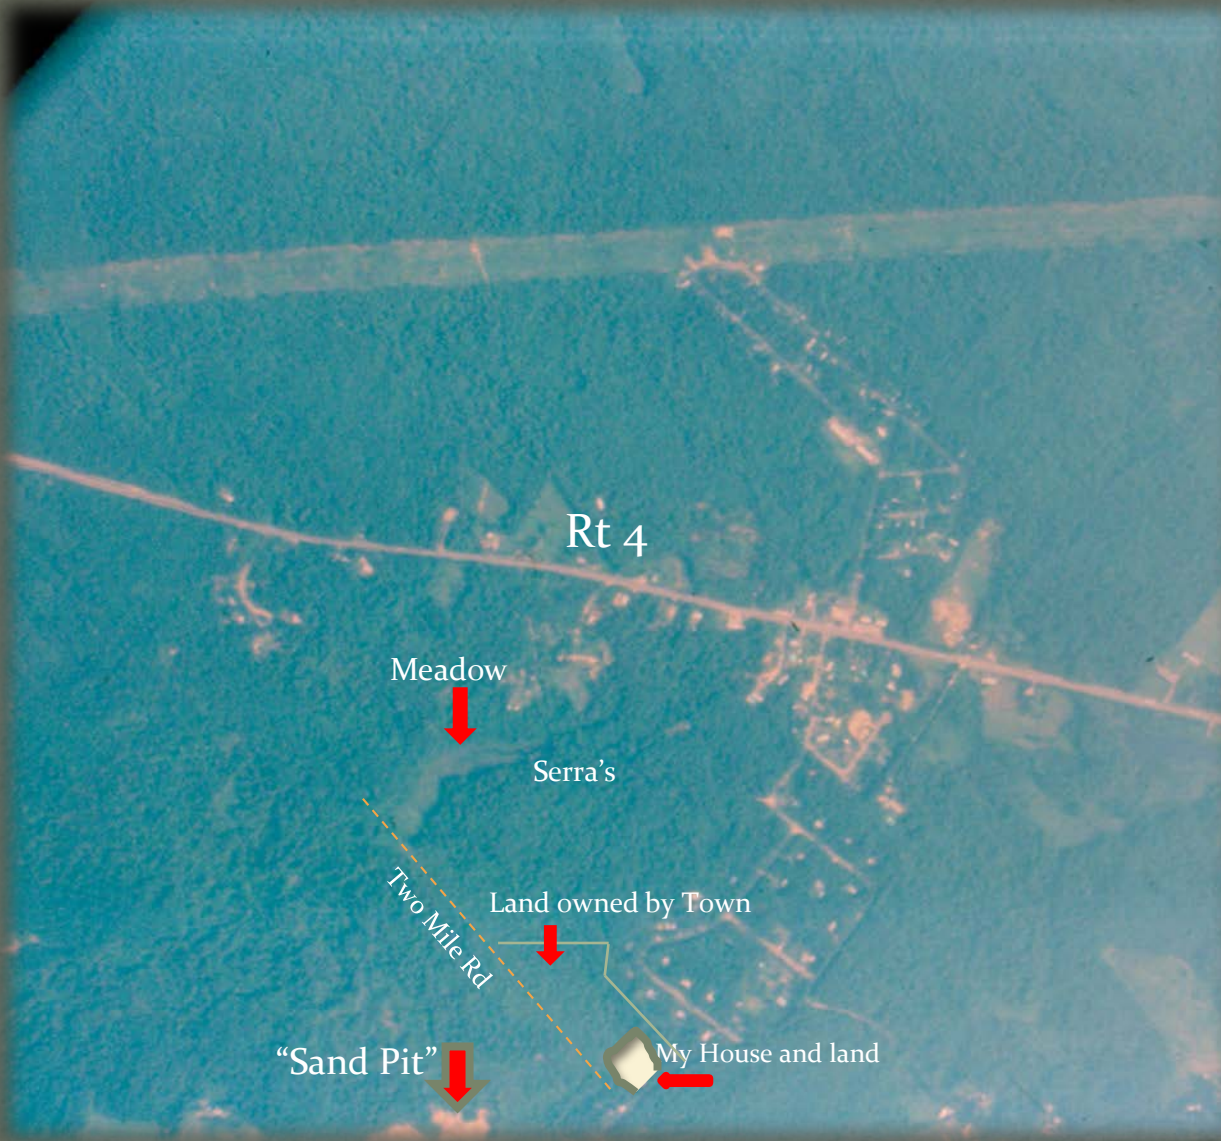
August, 1984 another view

Showing meadow.
Notice tip of sand pit
along the lower edge of
the photo.

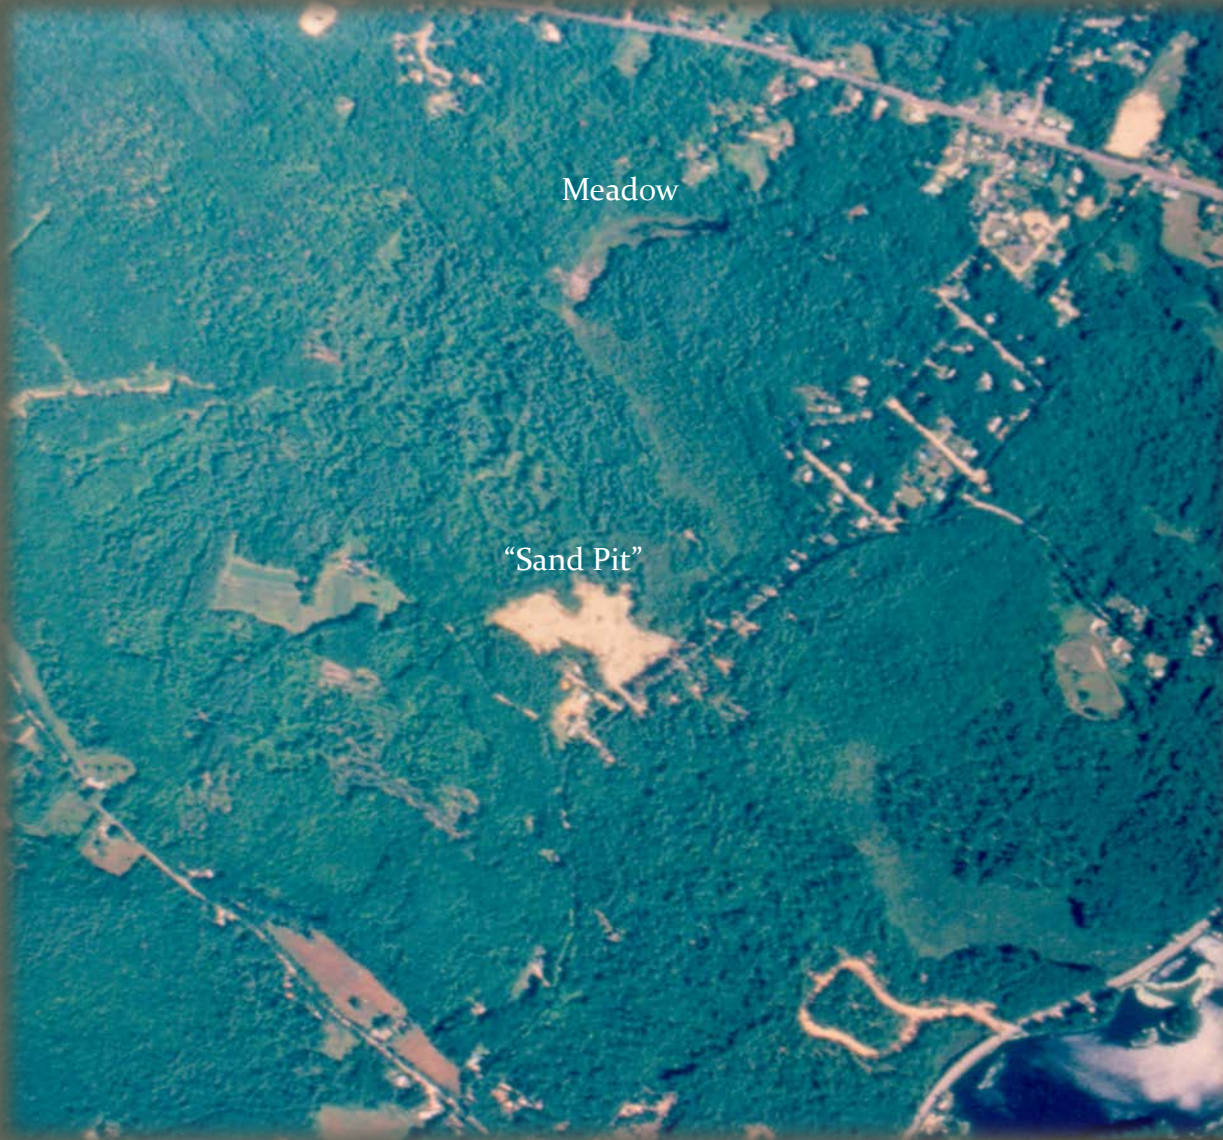
August 1985

Sand pit is in center. Note the meadow with the brook flowing through in the upper right, and the shape/size of the sand pit, which hasn't changed compared to the 1984 slides. Hopefully you are familiar with the landmarks by now, as the visual impact of this slide and the next one is important.

Keep in mind that the sand, gravel, and mature trees & vegetation on the land that was becoming the sand pit, absorbed a huge amount of water from rain and snow. The same amount of rain and snow will continue to fall on the area, and where will it go with nothing to absorb and use it?

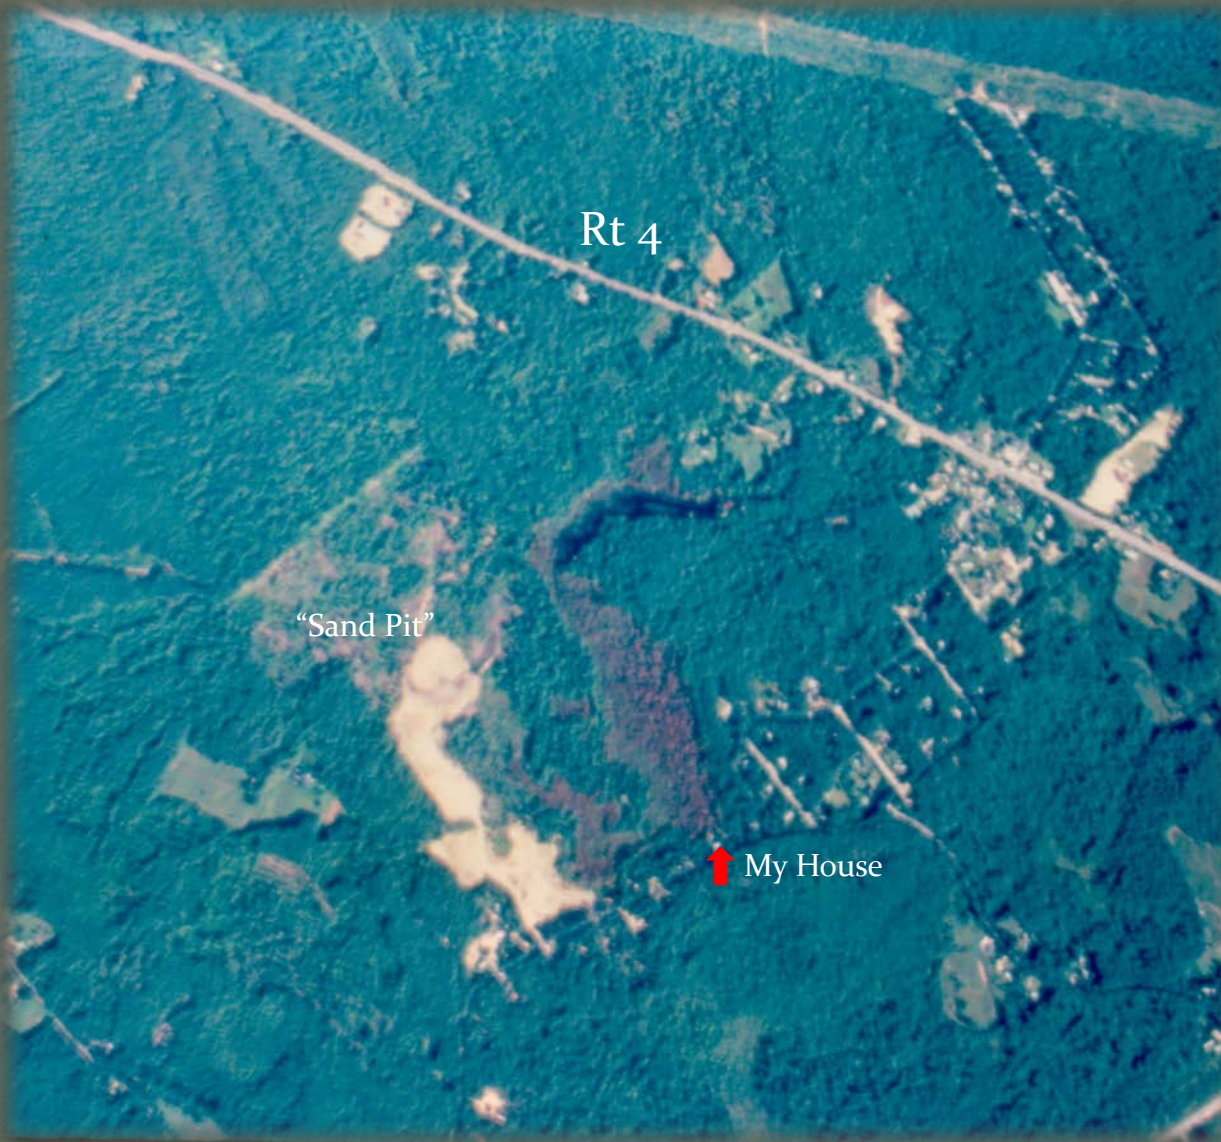
September 1986

Note the expansion of the sand pit, and the flooding of the meadow.

Water has backed up and impacted the trees in the area below the meadow, the land owned by the town - and flooded my back yard.

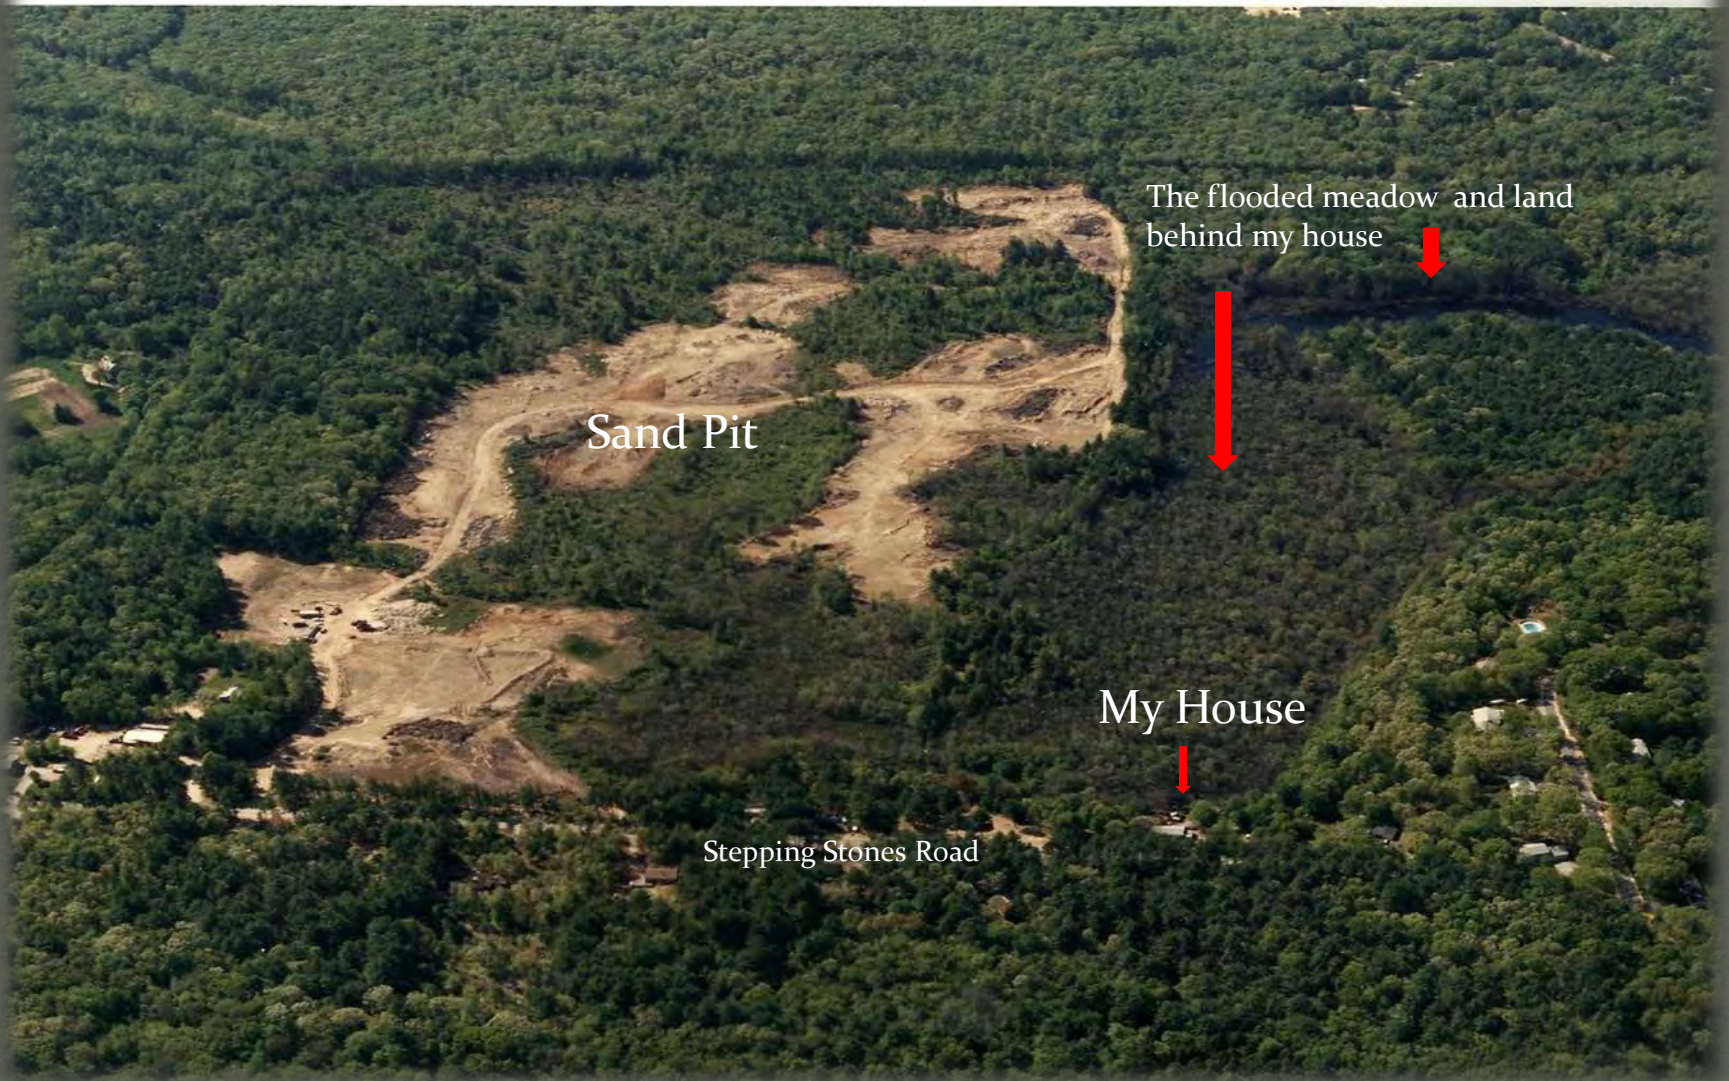
The flooded meadow and land behind my house

- The next three slides are aerial photos I had taken to show more clearly the extent of flooding. Because the land between my house lot and the Serra's land belonged to the Town of Barrington, I went to the Town to ask them to investigate the Sand Pit. I was told that the Town didn't care if their land (which was acquired for nonpayment of taxes) was flooded, and to take up my concerns with the Serra's to see if they would do something about the beaver dam, since the Town believed the beaver were the cause of the flooding.

- The beaver, which had been damming up Caldwell Brook since before 1953 (see the first slide), had no choice but to build their dam higher as more and more water began flowing through Caldwell Brook. This was due to the Sand Pit owner mining below the water table, and bulldozing two trenches across Two Mile Rd to drain his pit into the brook. When the town tried to get the pit owner to fill in the trenches, he simply installed large metal culverts, then filled over them. One culvert remains, as well as a ditch where the second culvert was removed.

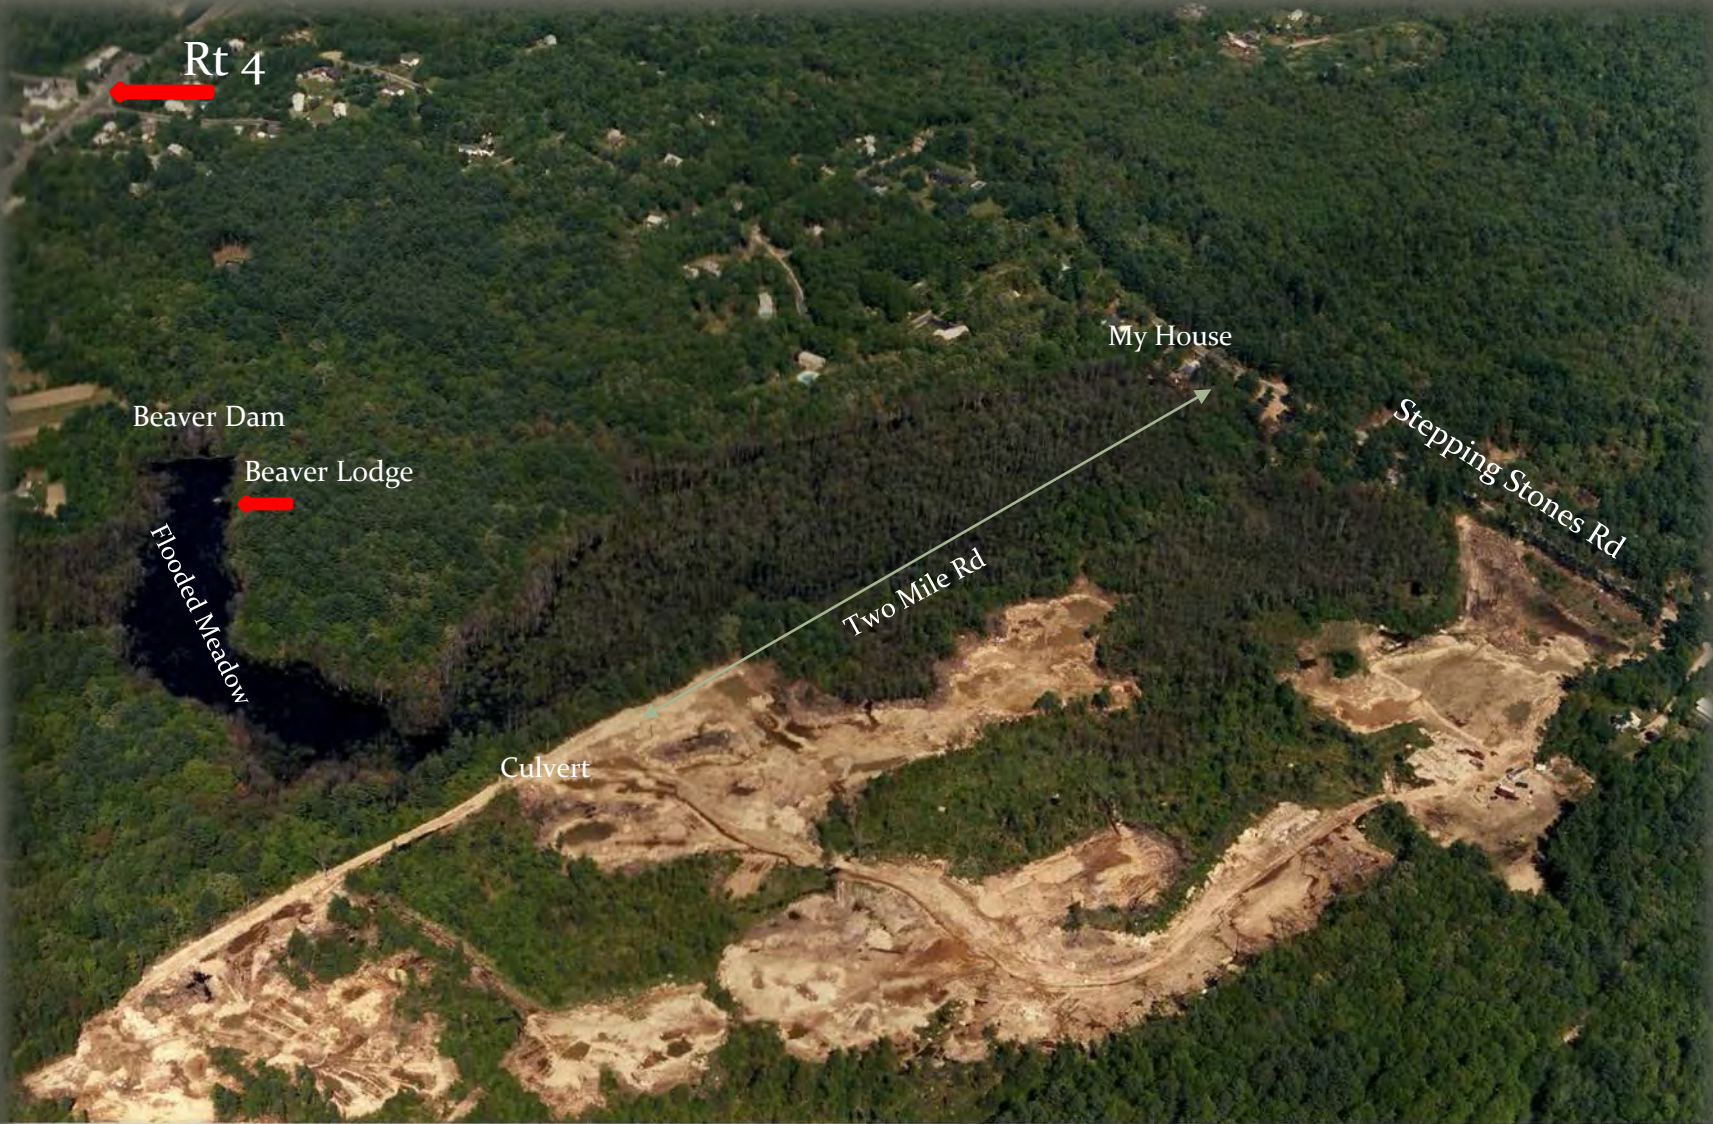
Beaver Dam

Beaver Lodge

Flooded Meadow

Culvert

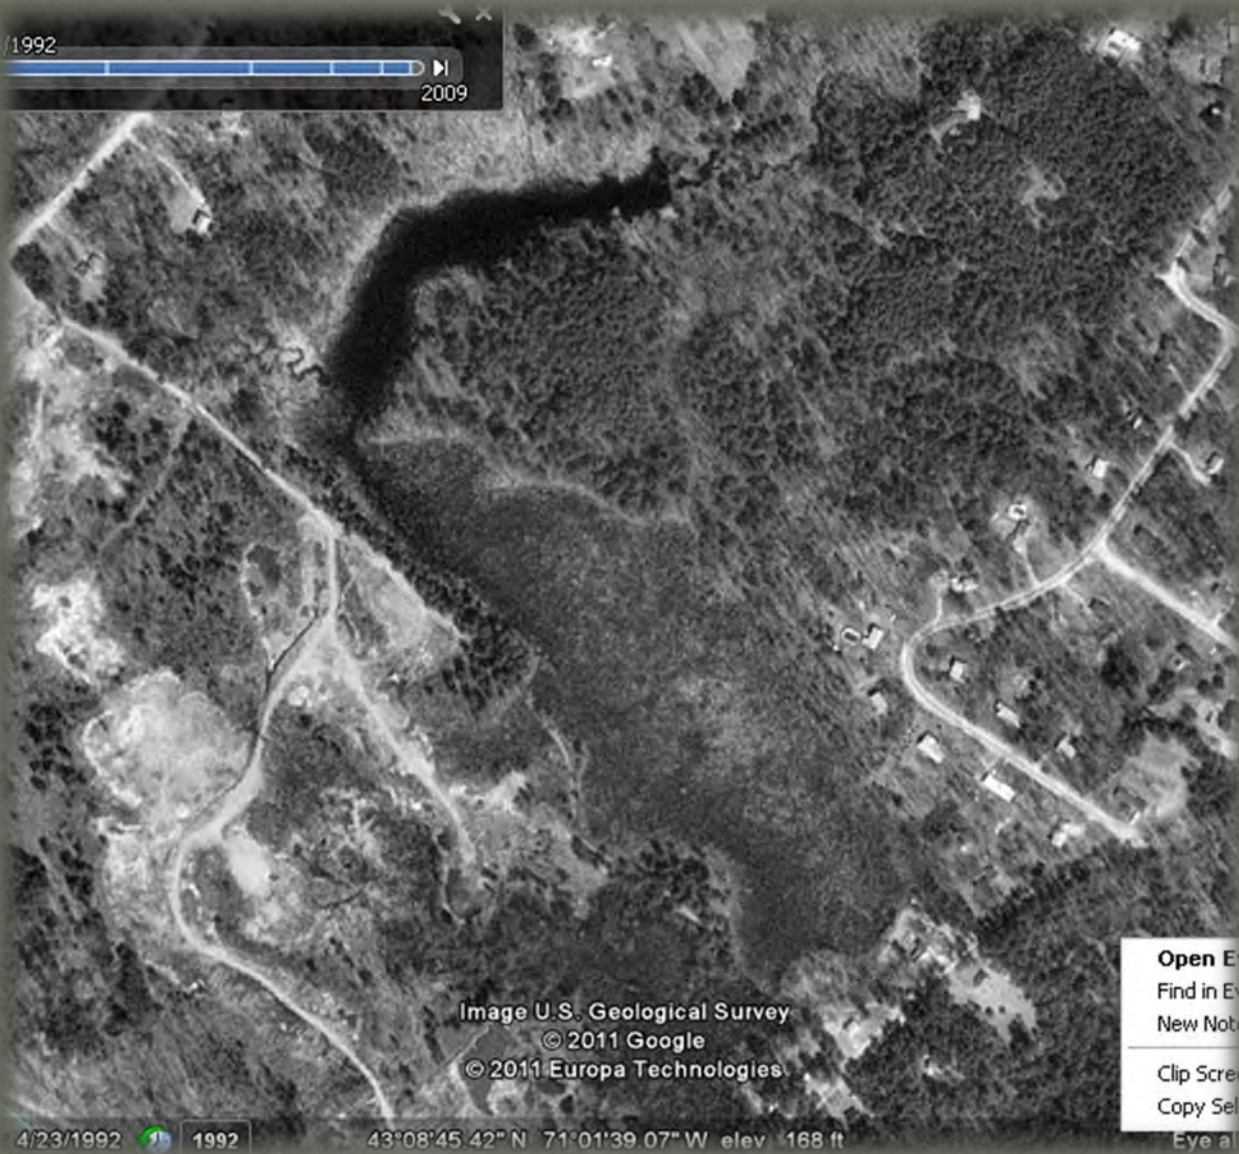
April 23, 1992

Six years later and the meadow is still a pond, and all trees on the land below have died. I had purchased the Town-owned land at Tax Sale, so that I would be an abutter to anyone on the sides and back of my home. The sand pit was no longer in operation.

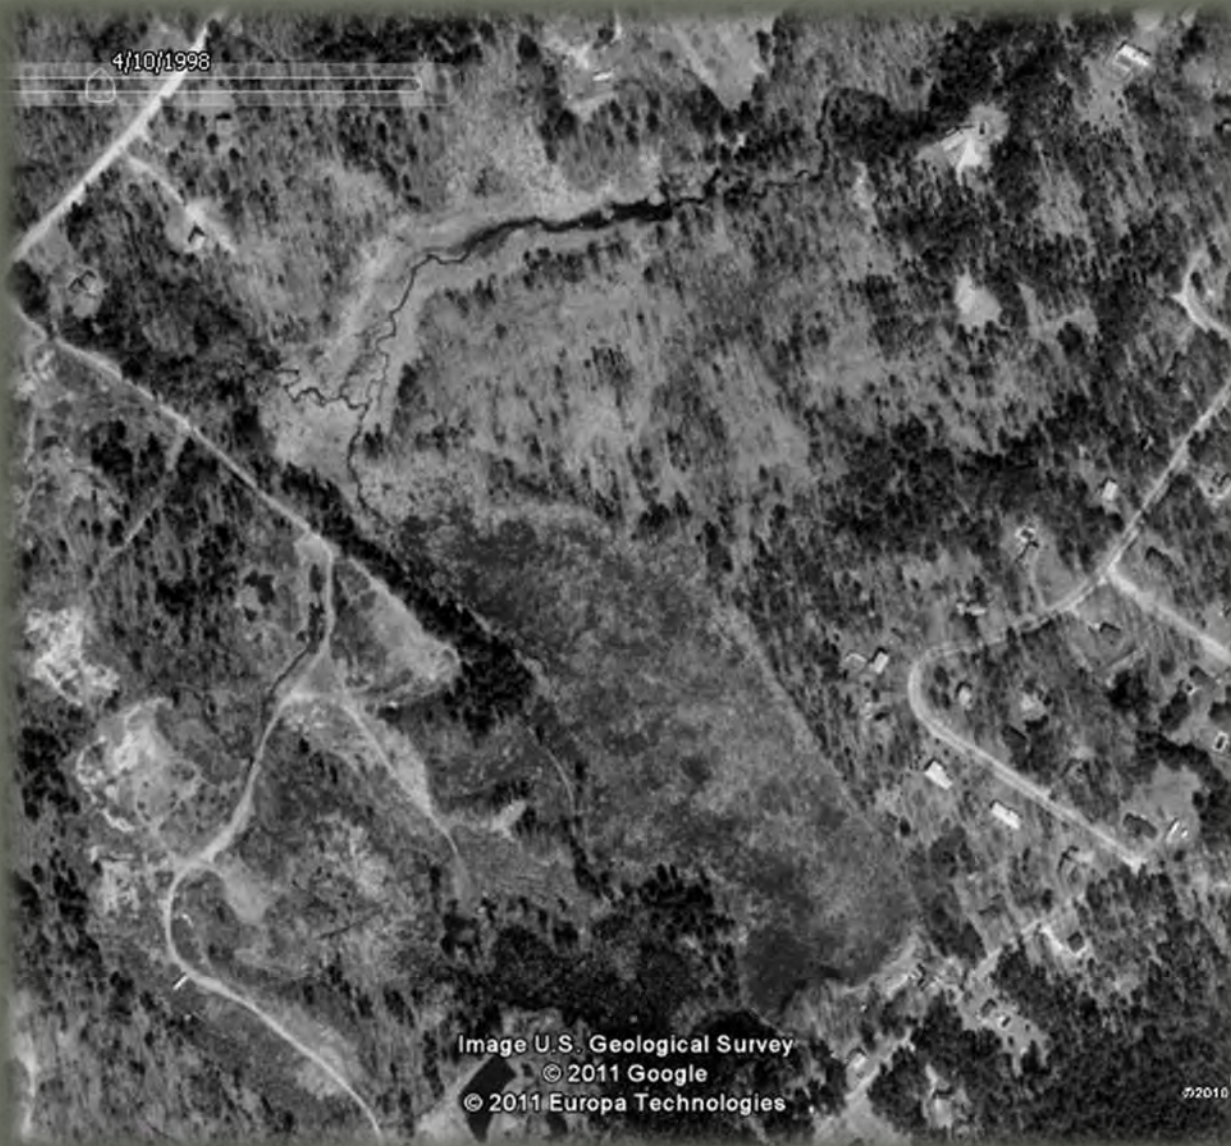
April 10,
1998

Twelve years later: A Fish & Game officer had helped me install a beaver box in the dam, out of fear the dam would break and wash out Route 4. The dam was so immense that we could only get down a couple of feet into the dam, but it helped relieve the amount of standing water on the land, and by now the beaver were gone, due to lack of food.

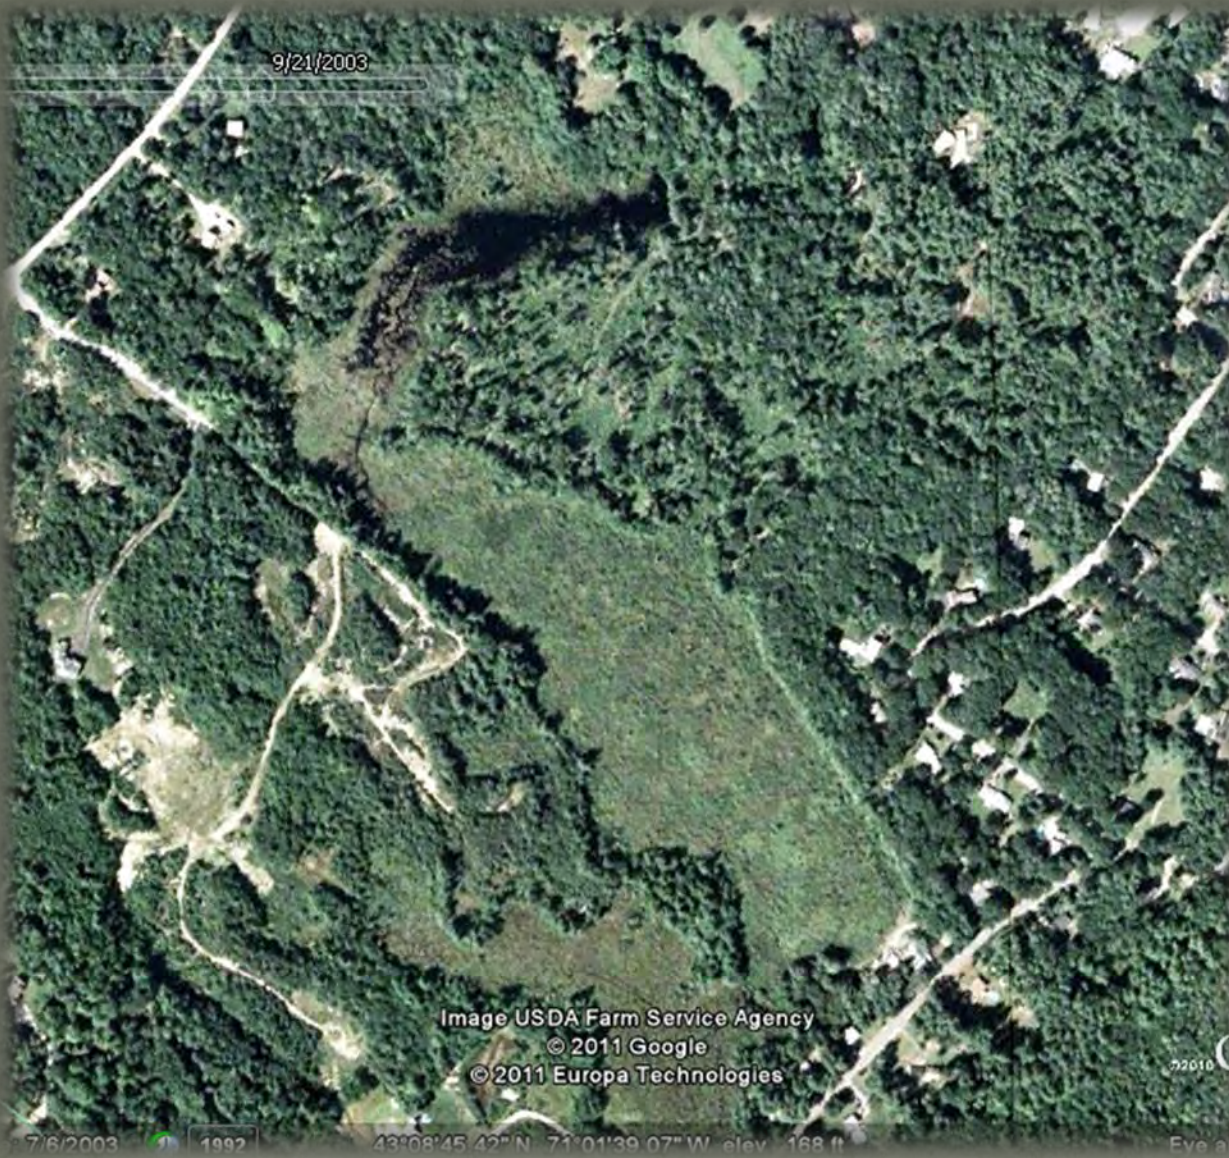
September
21, 2003

Seventeen years later.
Note the beaver are
back, and have repaired
the dam. The wooden
beaver box had
deteriorated, so very
little, if any, water
flowed through it.

Vegetation is wetlands
types. Still lots of small
dead trees sticking out
of the muck.

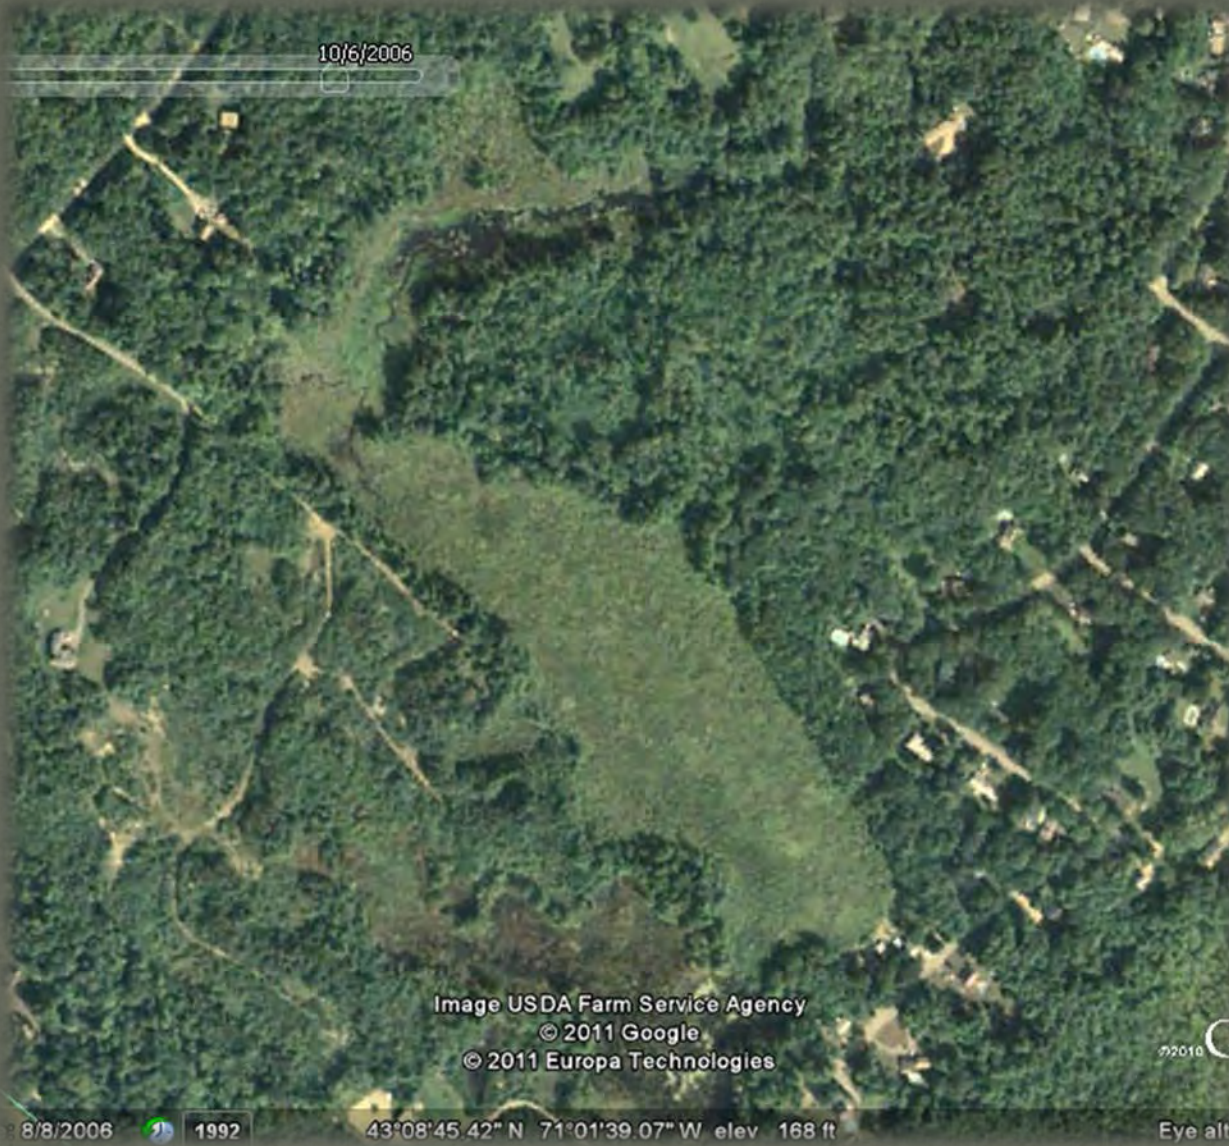
October 6, 2006

Twenty years later: The beaver have used up their food supply, and left, and the dam is gone, but the alteration to the land is still very much apparent. It had been declared Prime Wetlands some years earlier.

Note the vegetation covering the sand pit is returning. This new growth uses only a small percentage of the water that falls on that area compared to the mature trees that had been cut down.

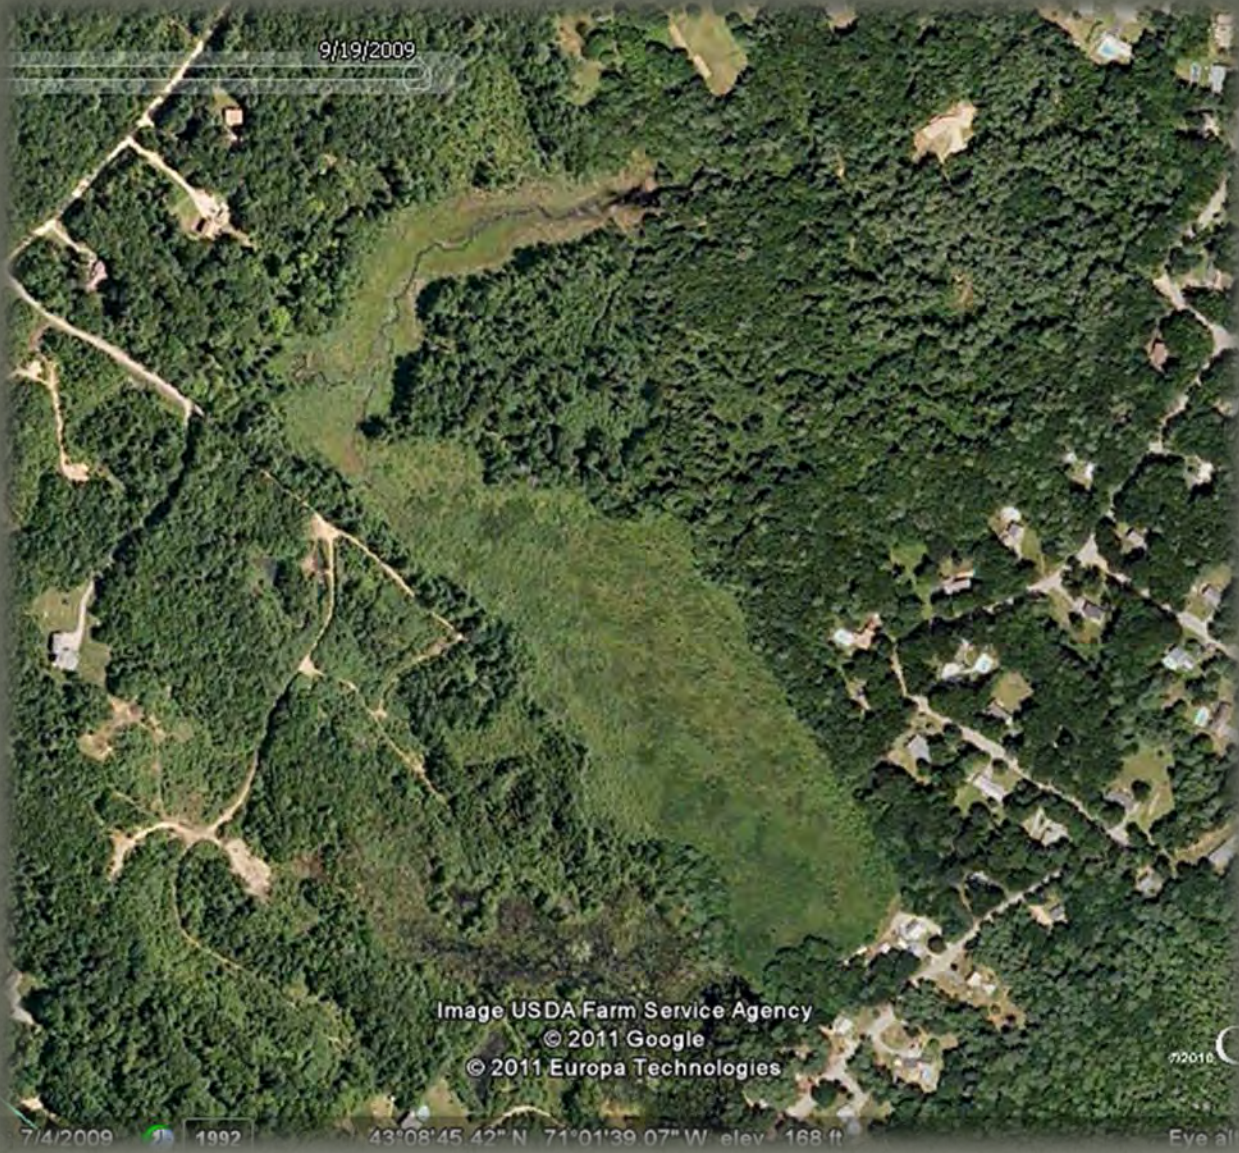
September 19,
2009

The improved
resolution of this
photo shows even
more clearly the land
that remains an
unusable, man-made
swamp.

The historic Two Mile
Road remains ruined
in many places and is
impassable off
Stepping Stones Road.
